Architectural Rehabilitation

Conditions Survey

Zion Hill Historic District - Conditions Survey Form

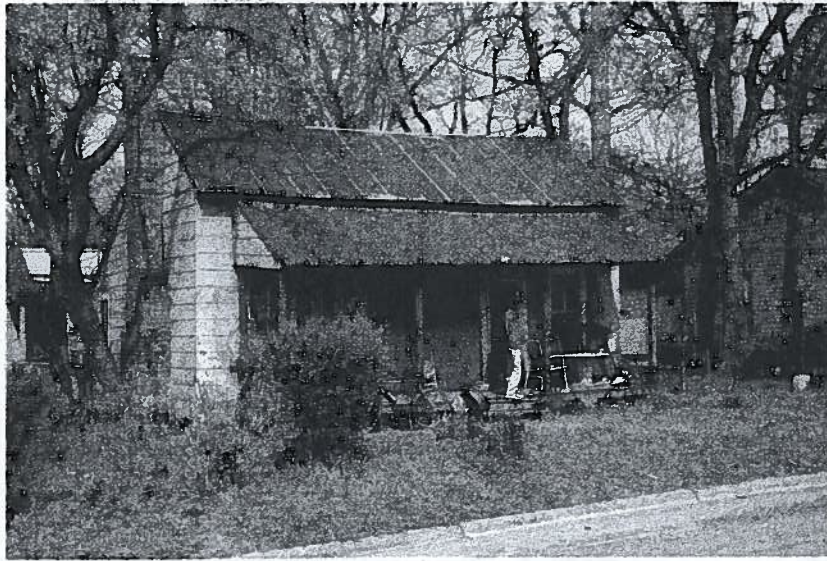
717 Bois D'Arc Street

Notes: CONSIDERED OLDEST SURVIVING HOUSE IN NEIGHBORHOOD - CAN BE RESTORED BUT OVERALL IN POOR CONDITION

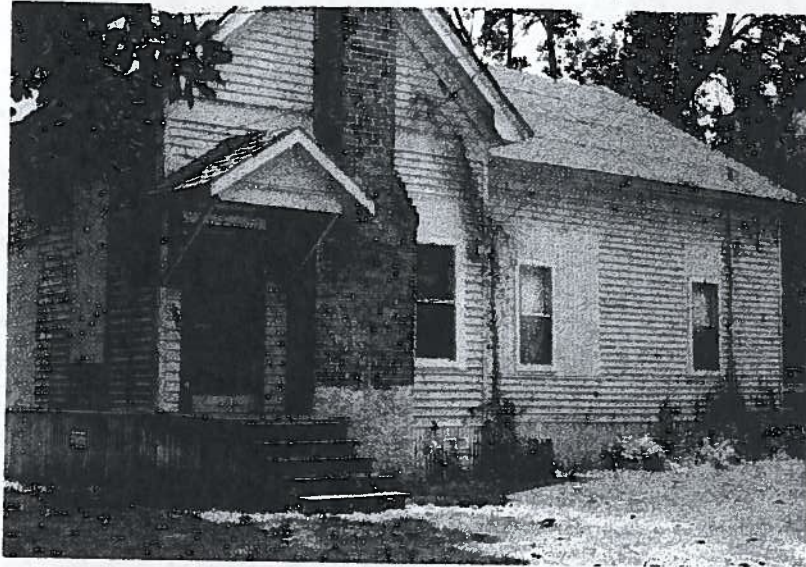
720 Bois D'Arc Street

- Ridge
- Slope
- Gable End (not original)

Notes: SIGNIFICANT ALTERATIONS - ORIGINAL PORCH REMOVED - WINDOWS ALTERED

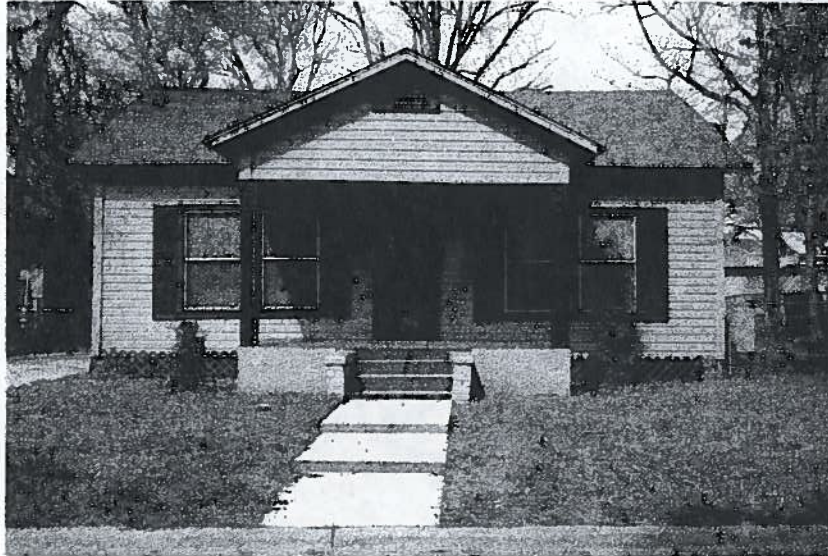
721 Bois D'Arc Street

Other Noteworthy Features NEW CONCRETE DRIVE AND PORCH

Notes: GOOD CONDITION - ALTERATIONS SIGNIFICANT - RETAINS LITTLE HISTORIC INTEGRITY

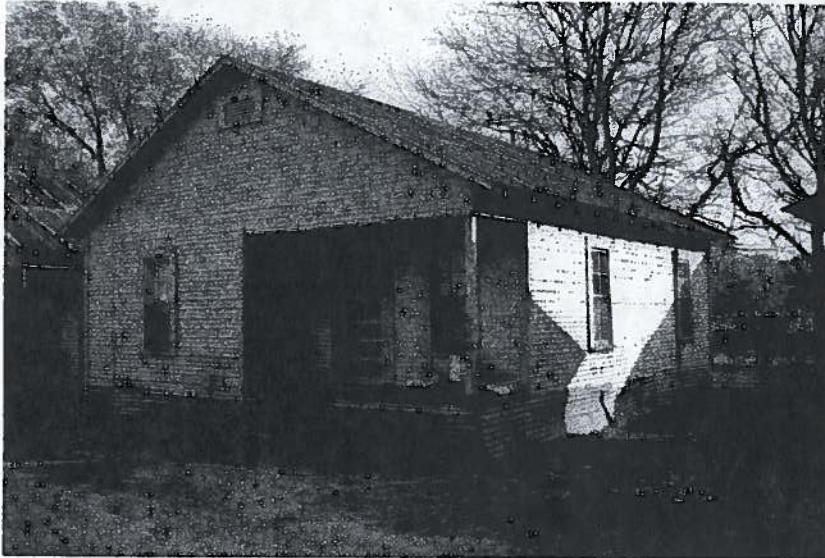
804 Ernest

Notes: GENERALLY GOOD CONDITION
