Architectural Rehabilitation

Conditions Survey

Zion Hill Historic District - Conditions Survey Form

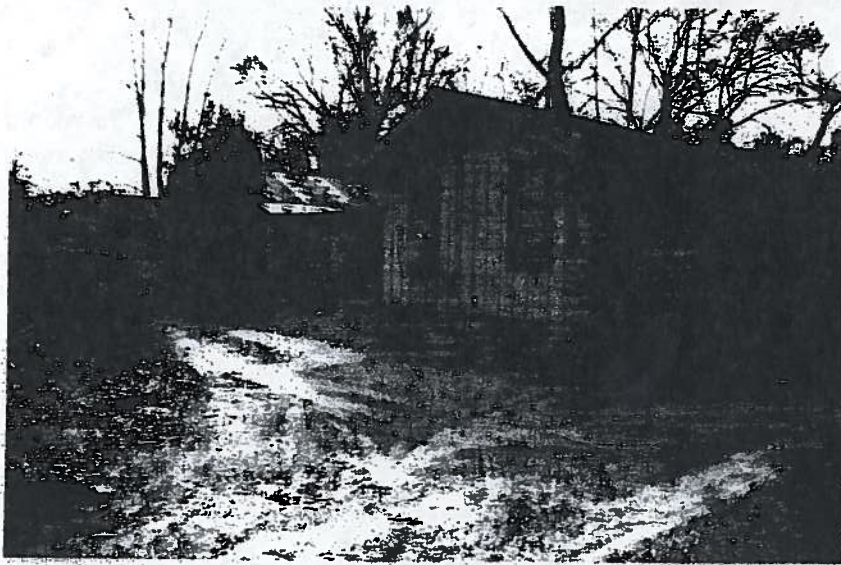
View of Mast Alley Looking Southwest

As most of the opportunities for new housing infill and street expansion in Zion Hill occur on the eastern or creek side of the district, it is felt that enhancing the landscaping potential along the creek, can best serve to fill the community's lack of recreational resources and directly link it to the creek and cemetery, creating a park space for the residents of Zion Hill. It also will best utilize flood-prone land and create a green edge conducive to additional infill housing. The hike and bike trail planned along Lanana Creek can be integrated into the plan and act as a linkage, up and down stream.

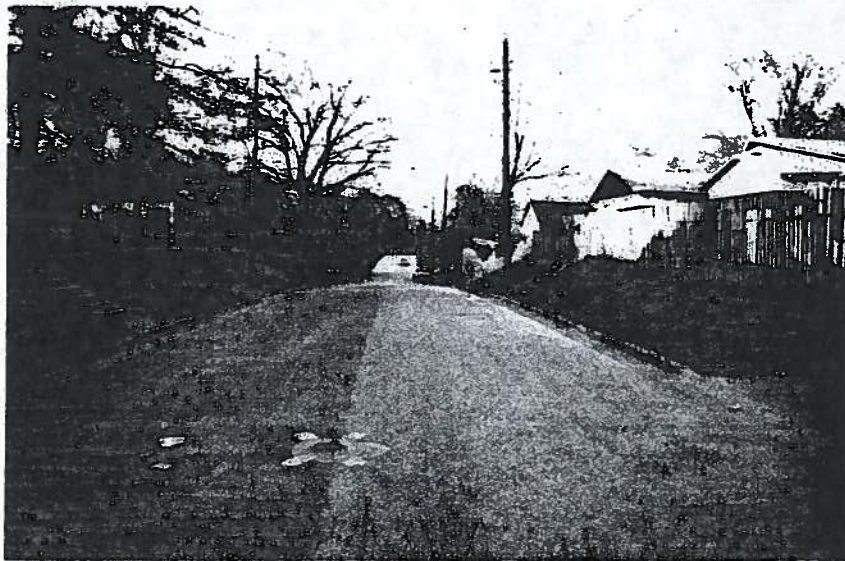
View of Richardson Street Looking North

Signage in the district should be upgraded to convey the special nature of the district and mark its entry points at the Zion Hill Baptist Church, the corner of Lanana and Park Streets, and the corner of Richardson and Park Streets. Period street name signs are recommended to be retained where existing and installed where missing. Entry "landmark" signage can provide Zion Hill with the definition it lacks, to both residents and passers-by and provide an improved image and sense of place.
